Trickey Pond Watershed-Based Protection Plan 2021-2031

March 2021

WATERSHED AND SHORELINE SURVEY REPORT

OCTOBER 2020

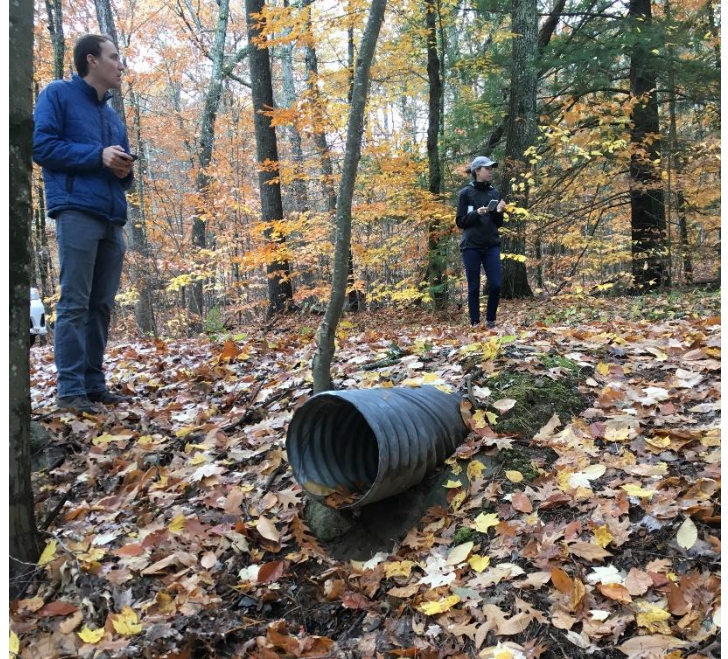
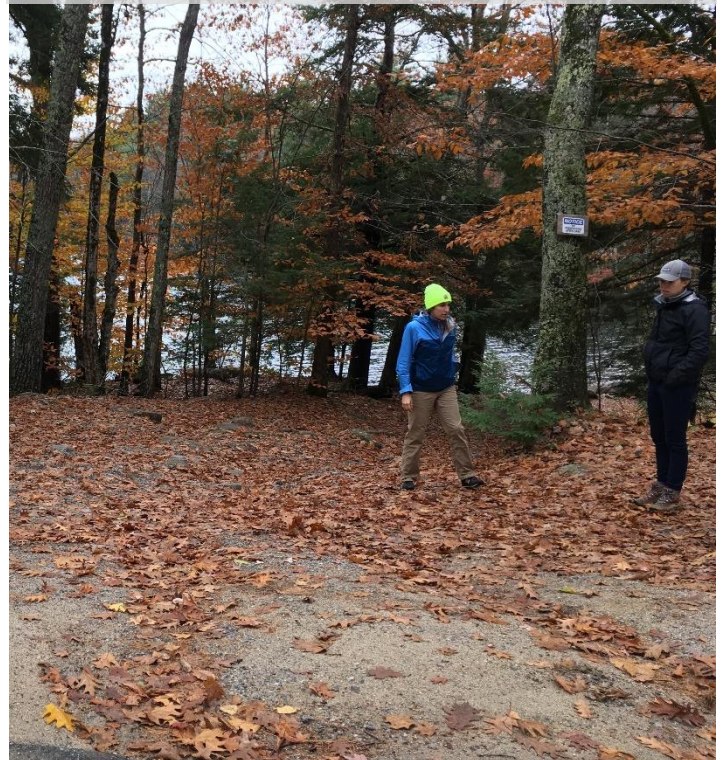
LEA and FBE staff document a perched culvert using handheld devices (above) and assess a lake public access point (below). Photo credit: FBE

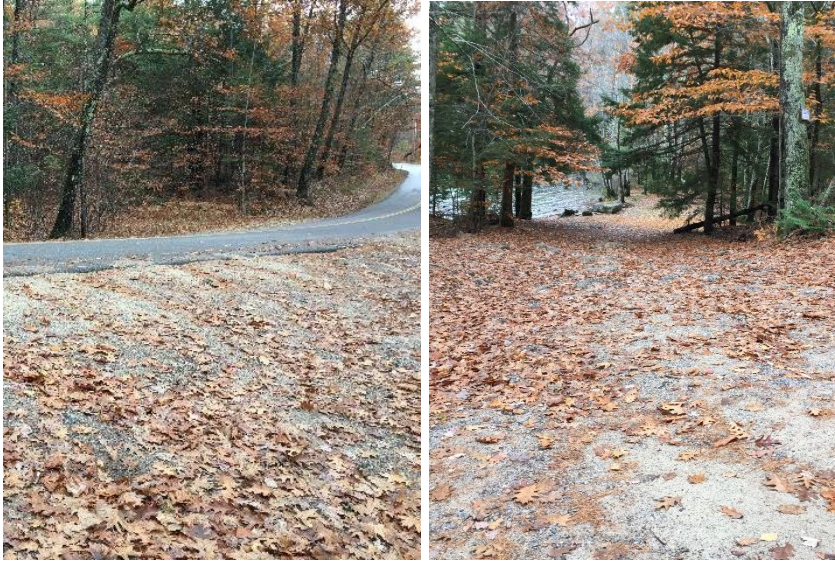
Observations: Road shoulder erosion is occurring alongside Lake House Road at the public access point and pond outlet adjacent to the road. Rill and gully erosion directly to the pond indicate severe concentrated flow and sediment transport. There is little to no buffer along the shoreline.

Lake House Road shoulder (left) and water access road to shoreline (right).

Recommendations: Install a water bar (or similar structure) to intercept runoff and direct water off the access road. Consider installing a catch basin or settling basin to remove debris and sediment from runoff prior to it reaching the pond or pond outlet. Additionally, improve the vegetated buffer between the access road and the pond to increase filtering capacity.

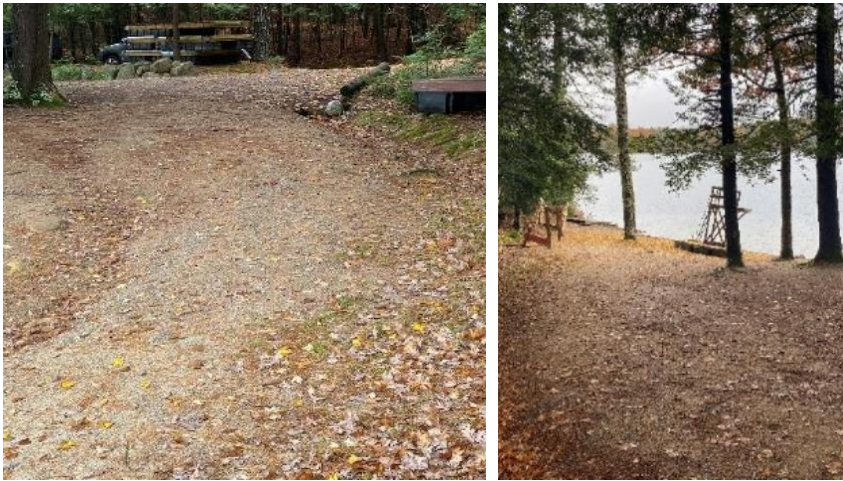
Camp Skylemar Shoreline (Site 1)

Observations: The shoreline and water access along the Camp Skylemar beach is experiencing significant runoff and shoreline erosion. The area has signs of concentrated flow and lacks a vegetated shoreline buffer. The culverts are clogged and need maintenance and cleaning.

Slope to water access (left) and Camp Skylemar beach (right).

Recommendations: We recommend trenching to control runoff and to prevent sheet and concentrated flow erosion. Perform regular culvert maintenance. Consider erosion control mulch to reduce sediment transport over unvegetated areas.

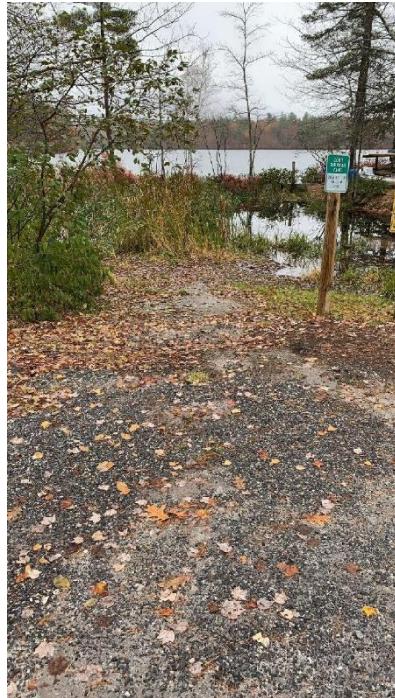
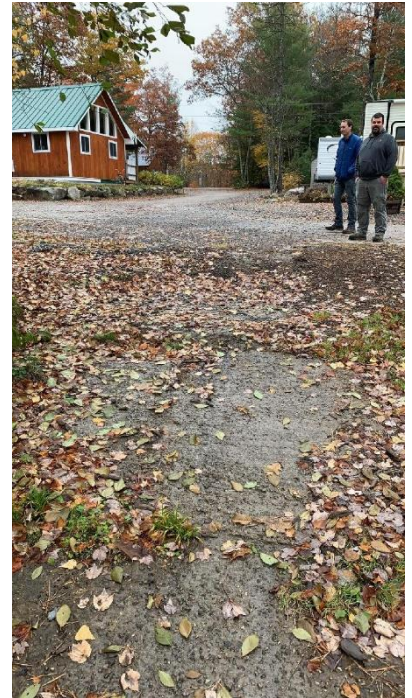
Boat Ramp at Loons Haven Campground (Site 5)

Observations: The gravel road to the discontinued boat ramp at Loons Haven Campground is experiencing a road crown failure, resulting in road surface erosion into the adjacent pond. Sediment is being transported directly to the water, as evidenced by rill and gully concentrated flow erosion. The area lacks a vegetated buffer.

Shoreline at old boat launch (left) and gravel road (right).

Recommendations: We recommend re-crowning the road and improving the vegetated buffer between the road and the shoreline. Consider installing a rain garden.

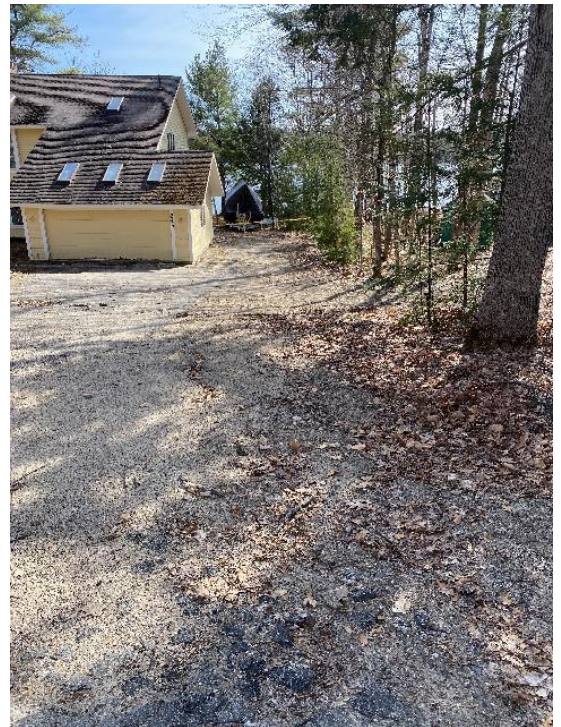
Property #243 on Trickey Pond Road (Site 34)

Observations: Sheet erosion is occurring on the driveway and adjacent area at residential property #243 on Trickey Pond Road. The area is moderately sloped and lacks a buffer between the eroding area and the pond.

Driveway and adjacent land on property #243.

Recommendations: Install a water diverter to control stormwater runoff. Vegetate the area to filter sediment and slow water speed.

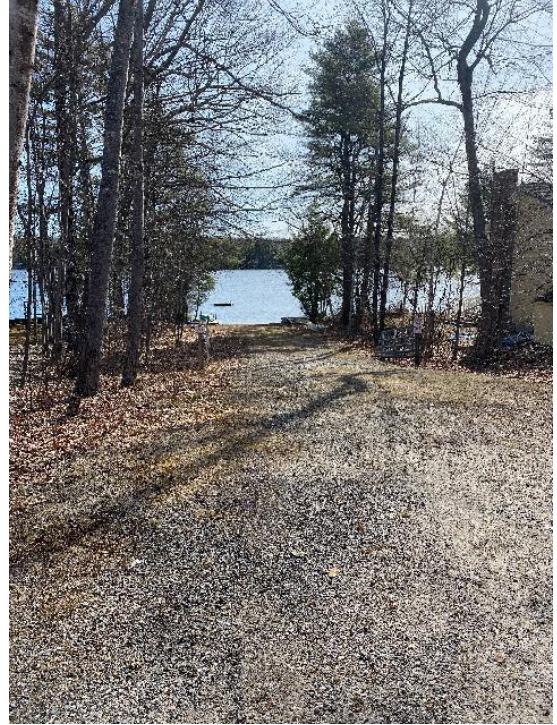
Boat Launch on Trickey Pond Road adjacent to #243 (Site 35)

Observations: The water access point boat launch on Trickey Pond road adjacent to property #243, serving as a boat launch, is experiencing road surface erosion, and resulting in shoreline erosion. The launch is moderately sloped, and water can flow directly to the lake transporting sediment.

Boat launch road adjacent to property #243.

Recommendations: We recommend installing multiple rubber razors on the launch to divert water off the roads surface. Consider installing vegetation or armoring on the road’s edge to slow and filter water.

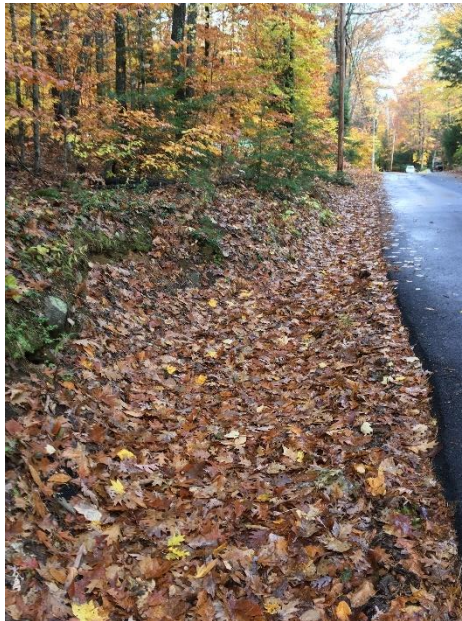
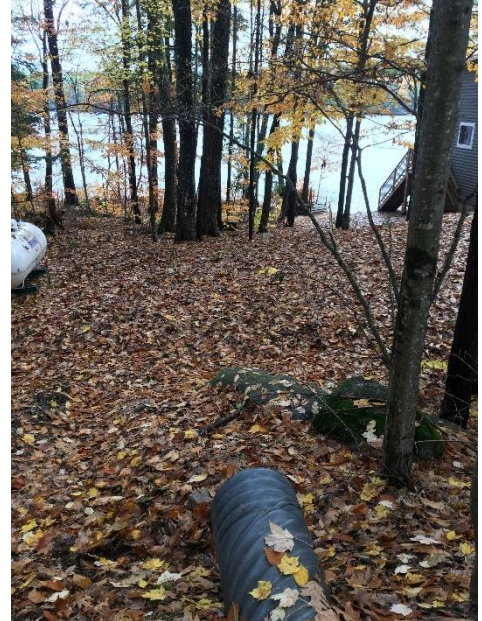
Perched culvert on Trickey Pond Road adjacent to #105 (Site 3)

Observations: The culvert on Trickey Pond Road adjacent to property #105 is clogged with debris and partially crushed. The outlet is hanging by six to 10 inches and is unstable. The slope to the water is steep.

Culvert inlet (not visible among debris) (left) and perched culvert outlet (right).

Recommendations: We recommend armoring the culvert inlet and outlet and installing a splash pool to reduce erosion and sediment transport directly to the water. Consider replacing the culvert with the appropriate size. Perform regular maintenance at the culvert inlet to prevent clogging and potential road overtopping. Armor and vegetate the path to the shoreline to reduce erosion and sediment transport.

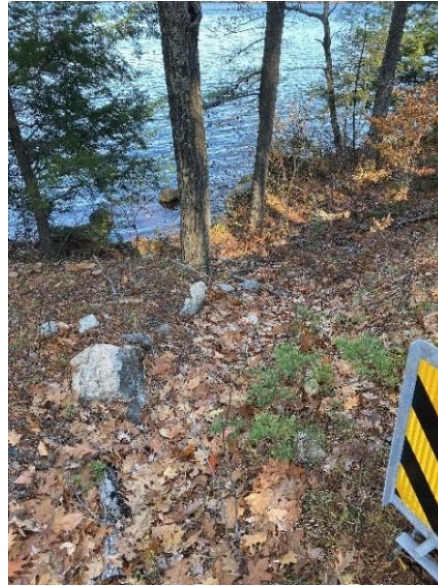
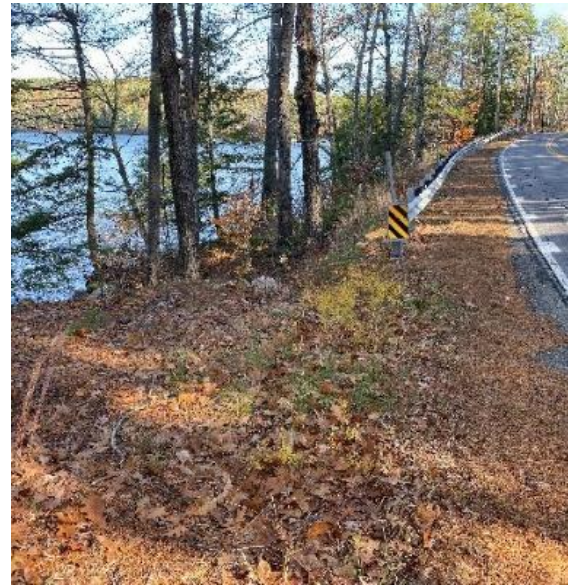
Route 114 adjacent to Trickey Pond Road Entrance (Site 14)

Observations: Route 114 is experiencing road shoulder erosion. Stormwater runoff is transporting sediment to the lake, evident from gully concentrated flow erosion down the steep slope to the shoreline.

Erosion on slope to water (left) and Route 114 road shoulder (right).

Recommendations: We recommend increasing vegetation on the slope and establishing runoff diverters to slow the speed of stormwater runoff.

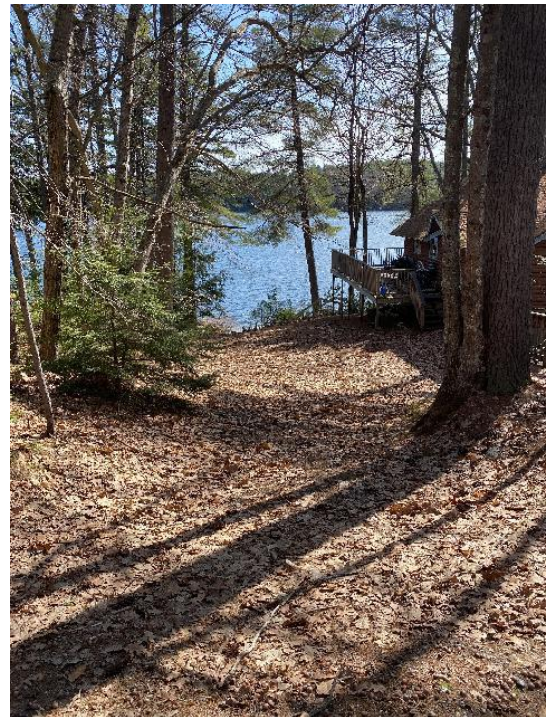
Driveway on Trickey Pond Road Property #93 (Site 24)

Observations: Property #93’s driveway on Trickey Pond Road is experiencing road surface erosion and concentrated flow erosion. The steeply sloped area leads to the water with minimal vegetation.

Driveway for property #93.

Recommendations: We recommend rubber water bar diverters to control the flow and speed of stormwater runoff and to filter the water through vegetation prior to flowing into the pond.

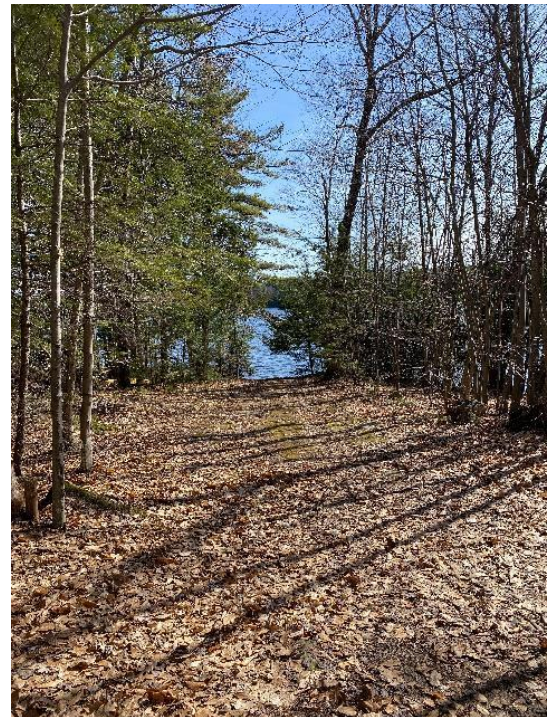
Water access point on Trickey Pond Road (Site 25)

Observations: The water access point located midway along Trickey Pond Road is experiencing road surface erosion, concentrated flow erosion, and shoreline erosion. The access road is moderately sloped and has signs of rill and gully erosion.

Water access point.

Recommendations: We recommend installing rubber water bar diverters to control the flow and speed of stormwater runoff. Considering encouraging vegetation to allow sediment in runoff to be filtered prior to leading to the pond.
