Trickey Pond Watershed-Based Protection Plan 2021-2031

March 2021

WATERSHED AND SHORELINE SURVEY REPORT

OCTOBER 2020

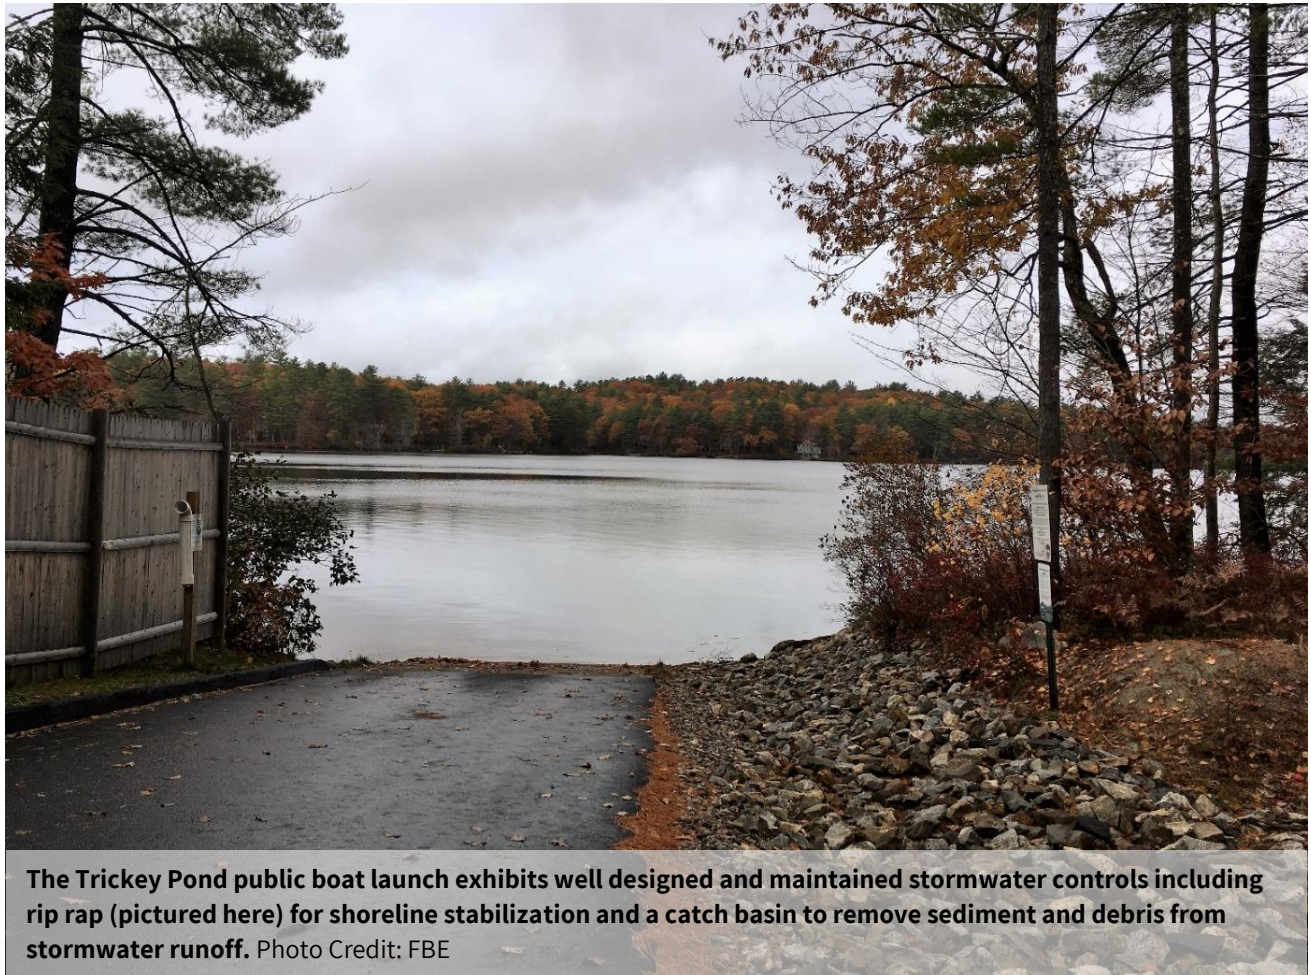
The Trickey Pond public boat launch exhibits well designed and maintained stormwater controls including rip rap (pictured here) for shoreline stabilization and a catch basin to remove sediment and debris from stormwater runoff. Photo Credit: FBE

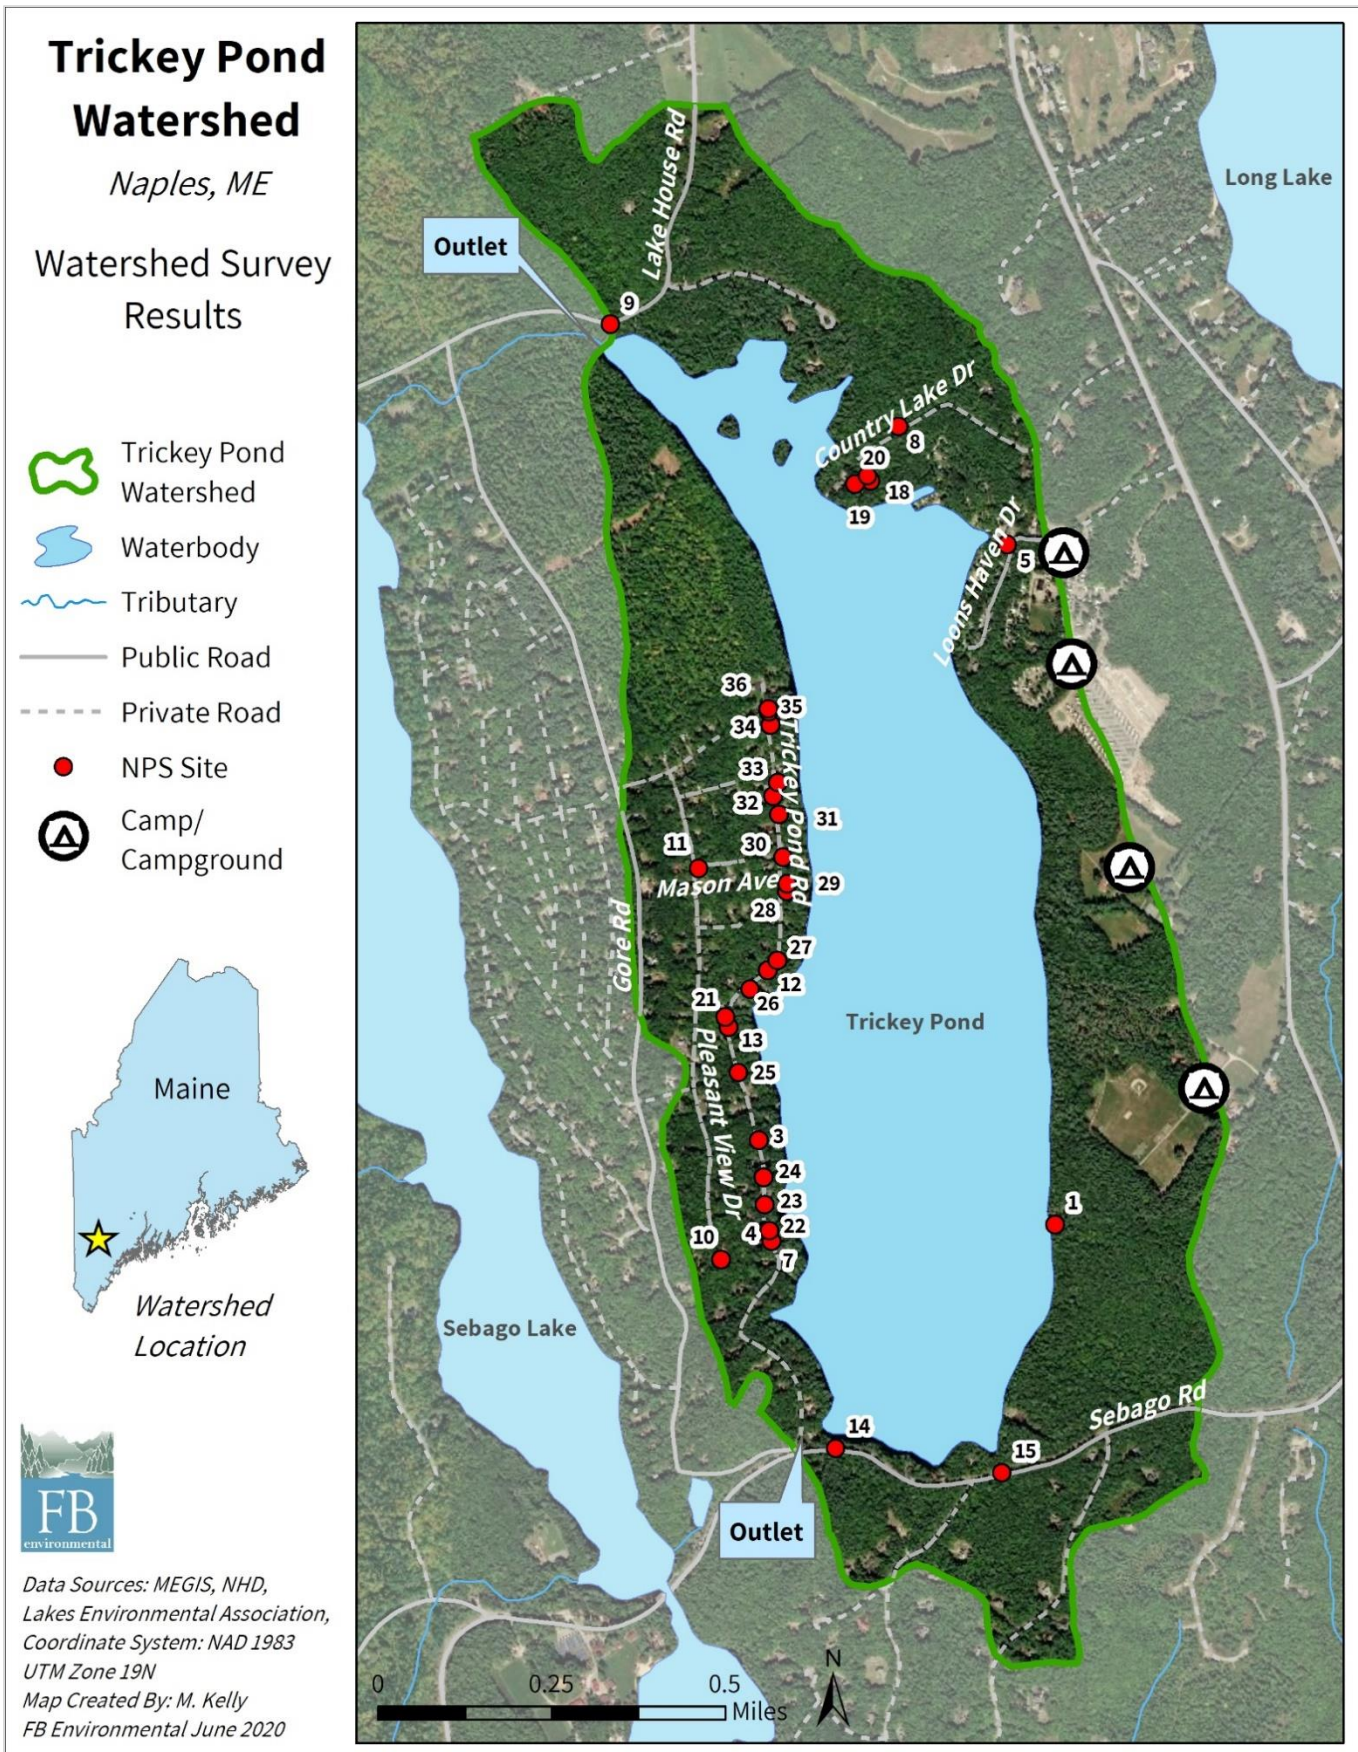
Figure 4. Potential nonpoint source pollution sites identified in the 2019 - 2020 watershed survey.

The locations of the 32 sites are shown in Figure 4, of which nine are rated as high priority due to erosion severity, erosion area size, and lack of buffering. The high priority sites are described below. The full results of the watershed survey, including specific recommended actions, are included in Appendix A.

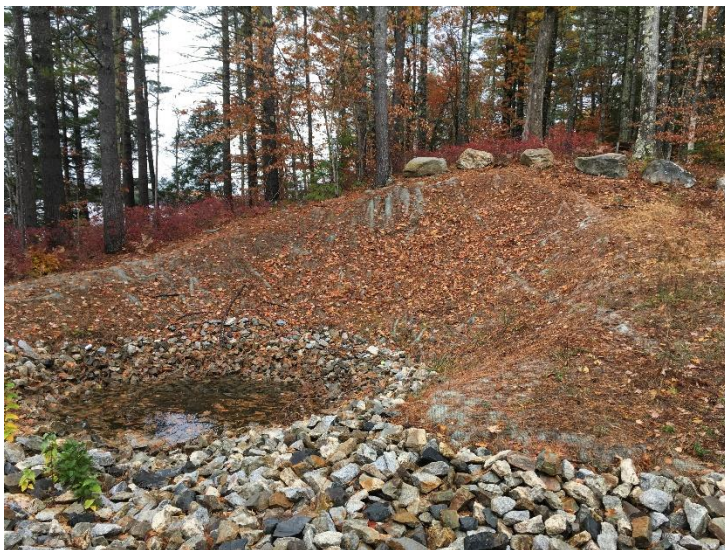
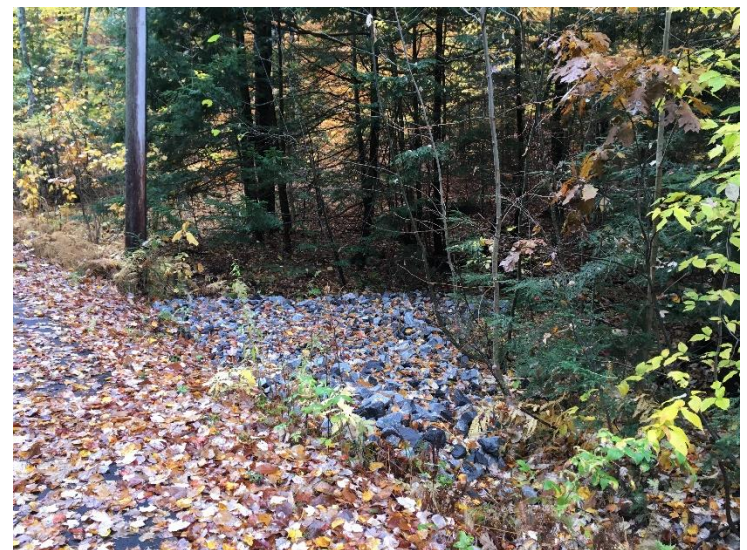
Examples of effective stormwater controls: catch basin and rip rap at the Trickey Pond public boat launch (left) and road shoulder armoring on Trickey Pond Road (right). Photo credit: FBE

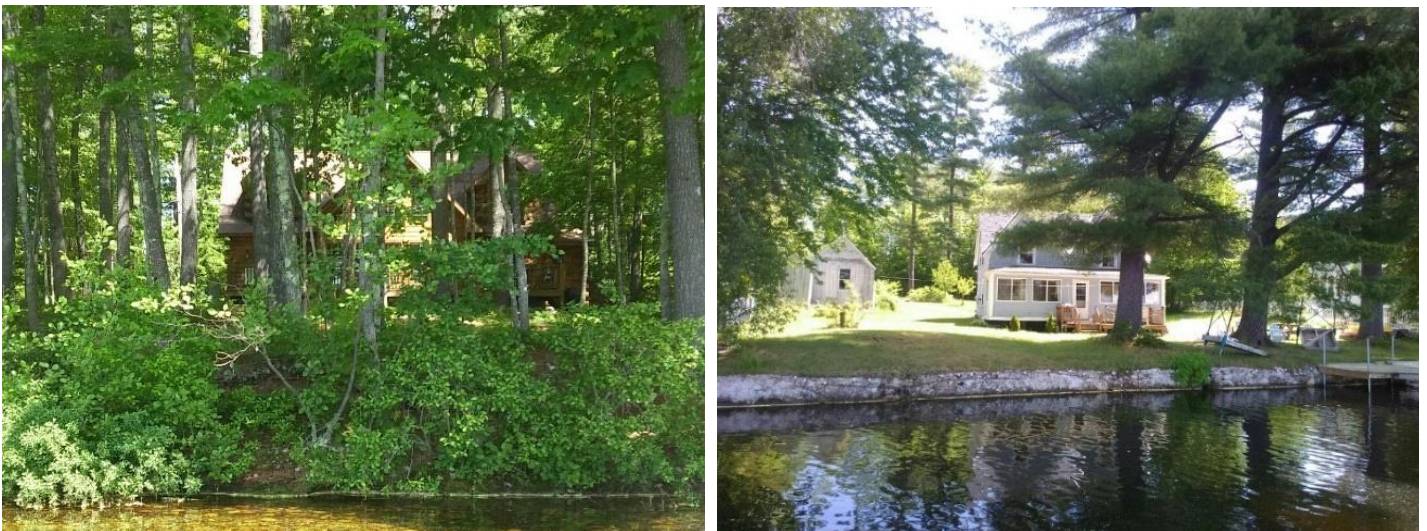
A property with trees and shrubs between the shoreline and structure creating a natural buffer (left), and a parcel vulnerable to stormwater runoff because of limited shoreline buffer (right).

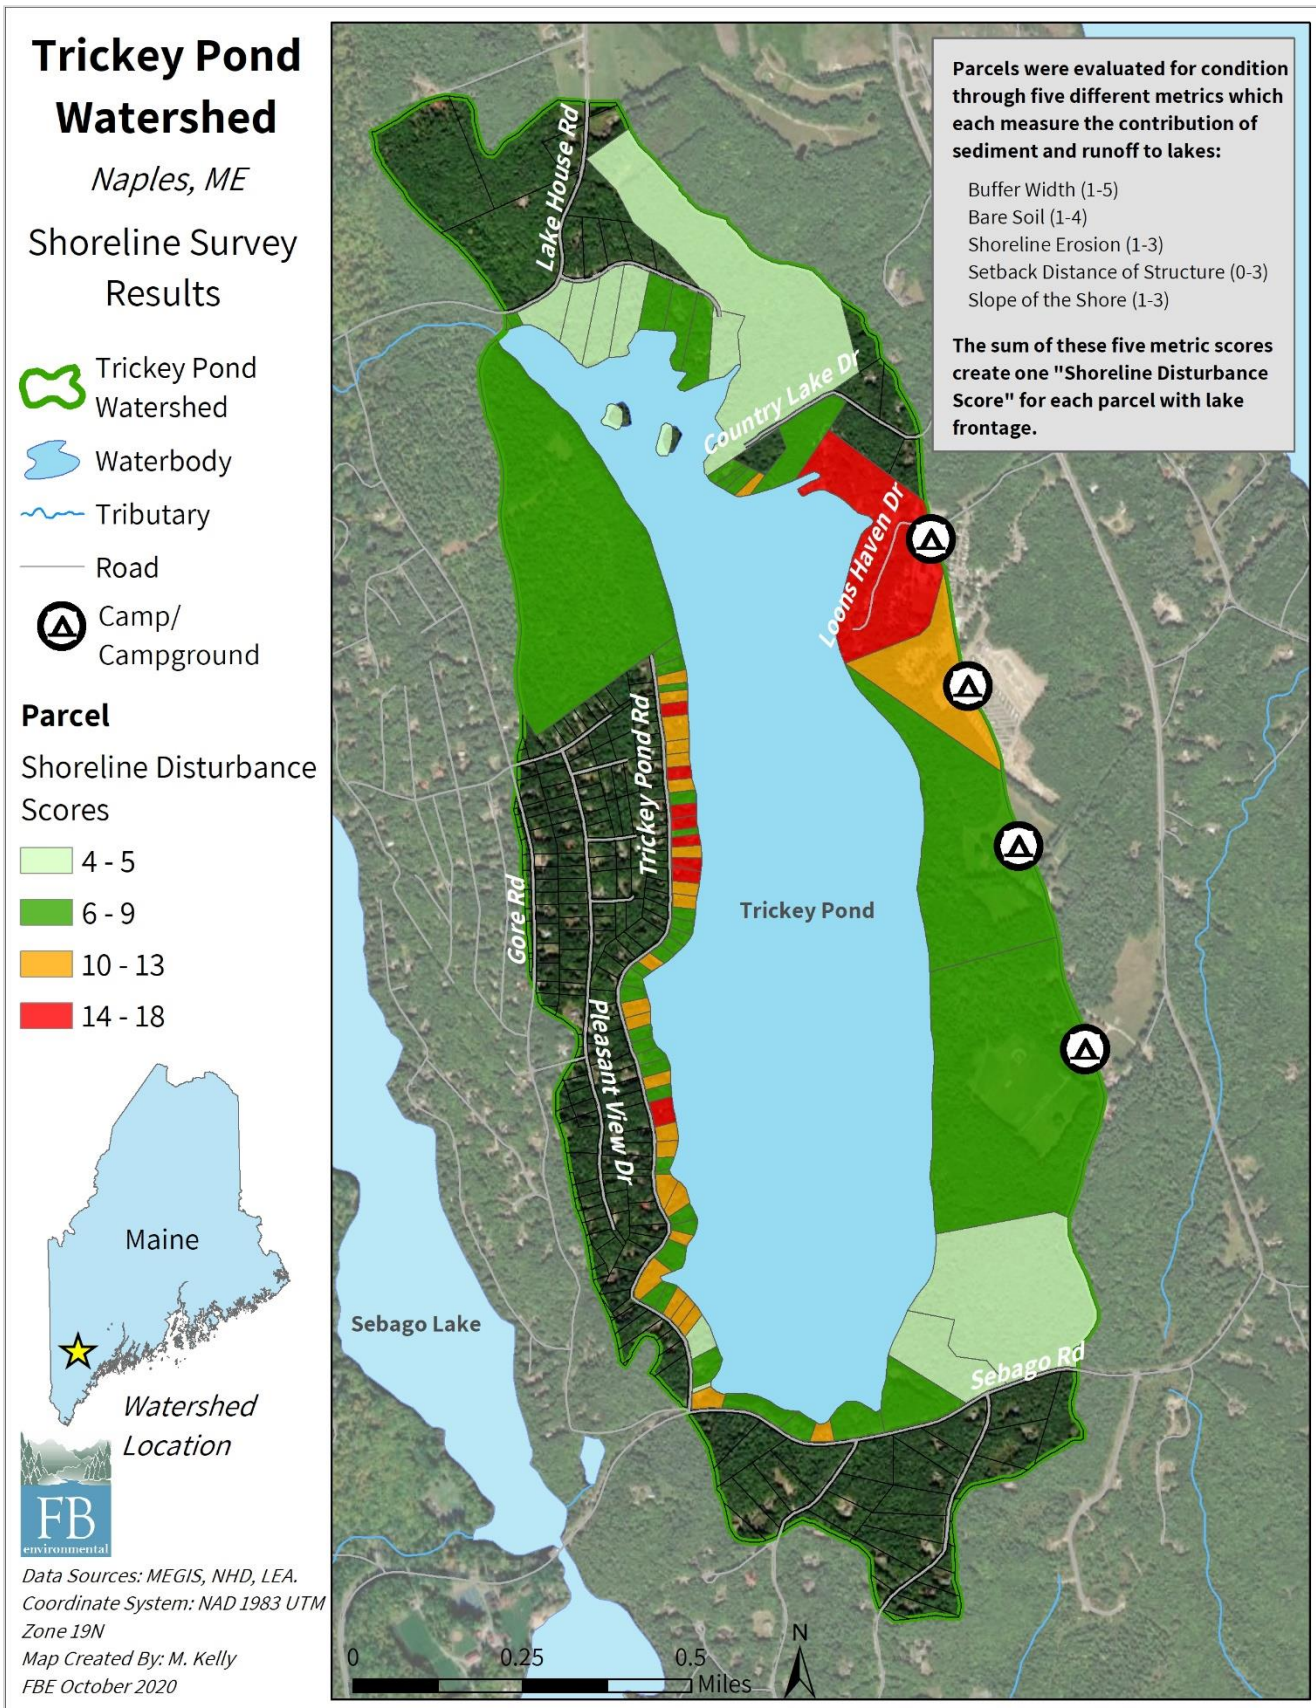
Figure 6. Map of shoreline disturbance scores for individual shorefront properties on Trickey Pond. Refer to Table 2 caption for description of color coding.

Figure 6 displays the mapped distribution of parcel scores. The spatial distribution highlights areas possibly contributing to polluted runoff and can be used to prioritize areas of shoreline frontage for restoration. Shorefront landowners can implement many best management practices individually that reduce the potential for NPS pollution and still allow for an aesthetically pleasing shorefront.

Best management practices to address common nonpoint pollution site issues seen along the shoreline survey include: 1) planting vegetated buffers with native plants to improve inadequate buffers, 2) planting rain gardens, using erosion control mix, and removing artificial sand to reduce the presence of bare soil, 3) filtering path and driveway runoff into the ground using runoff control diverters and check steps to prevent shoreline and bank erosion or destabilization, and 4) ensuring the septic system is fully functioning to mitigate potential harmful effects on Trickey Pond’s water quality due to development close to the shoreline.
